USAAMRDL TECHNICAL REPORT 71-50

**BALLISTIC VULNERABILITY OF BORON/EPOXY
DOUBLE-WALL DRIVE SHAFTS**

October 1971

CONTRACT DAAJ02-71-C-0021
SIKORSKY AIRCRAFT DIVISION
UNITED AIRCRAFT CORPORATION
STRATFORD, CONNECTICUT

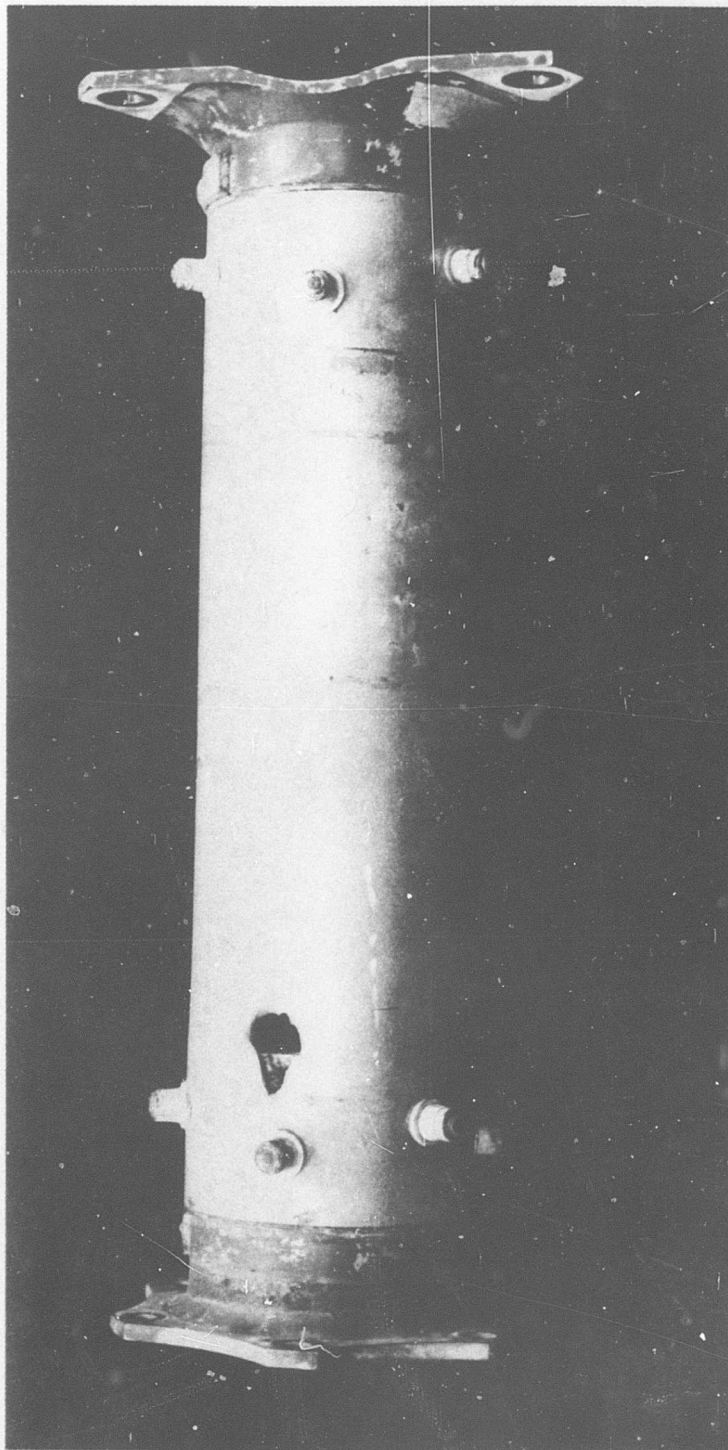
FIGURE 22. Aluminum Specimen 10, Entrance Hole Damage.
Torque on Impact = 16,350 in.-lb,
Residual Strength = 22,000 in.-lb.

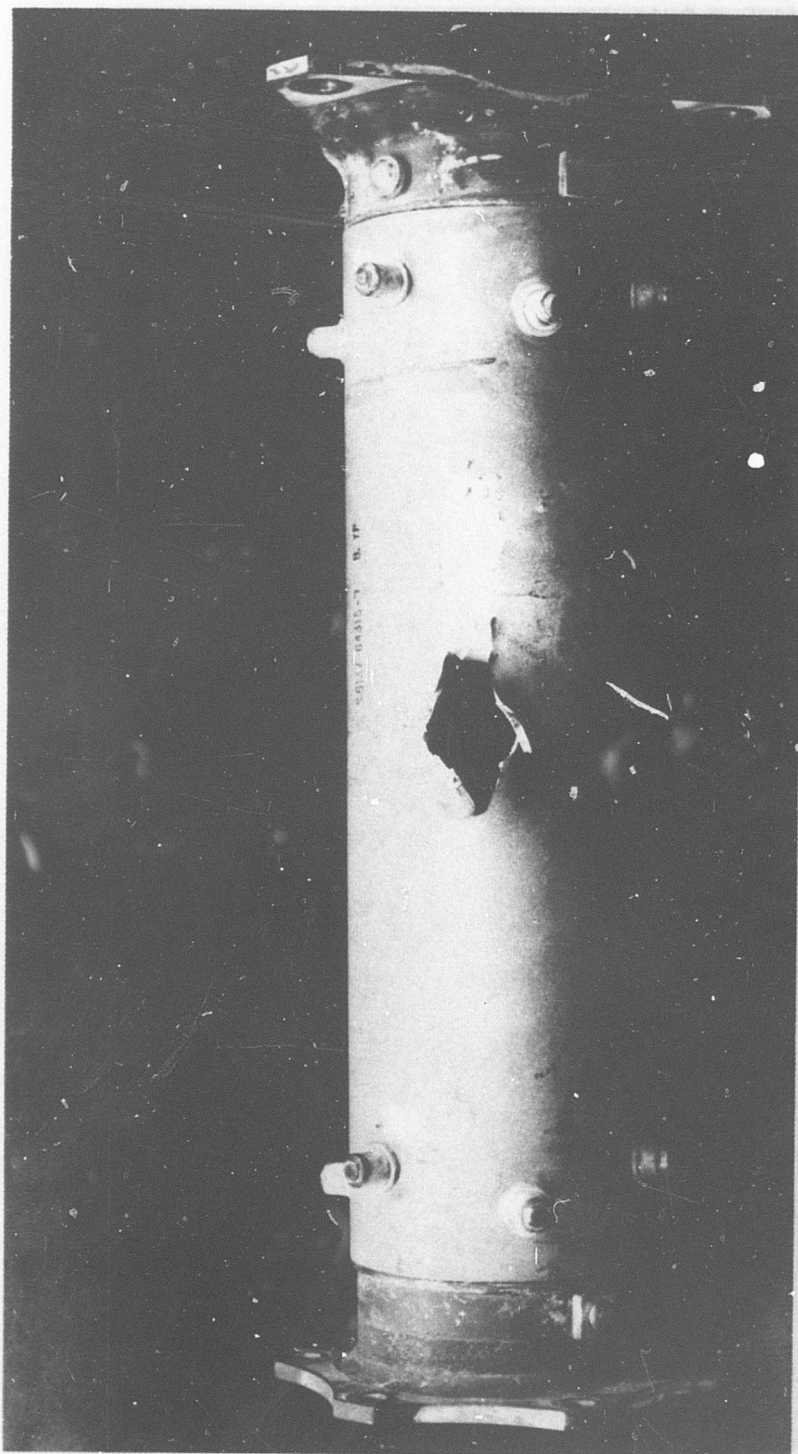
Figure 23. Aluminum Specimen 10, Exit Hole Damage.
Torque on Impact = 16,350 in.-lb,
Residual Strength = 22,000 in.-lb.
